## LEAD IN PAINT CERTIFICATION

Client: Roger Archibald  
*Inspection at:*  
490 Macdonough Street, Lower Level  
Brooklyn, NY

**RE: Lead-Based Paint Inspection @**  
490 Macdonough Street, Lower Level  
Brooklyn, NY

**LEAD-BASED PAINT PRESENT-Not in a Hazardous State**  
Walls\*, Ceilings\*, Baseboard, Window & Door Components, Closet & Cabinet  
Components

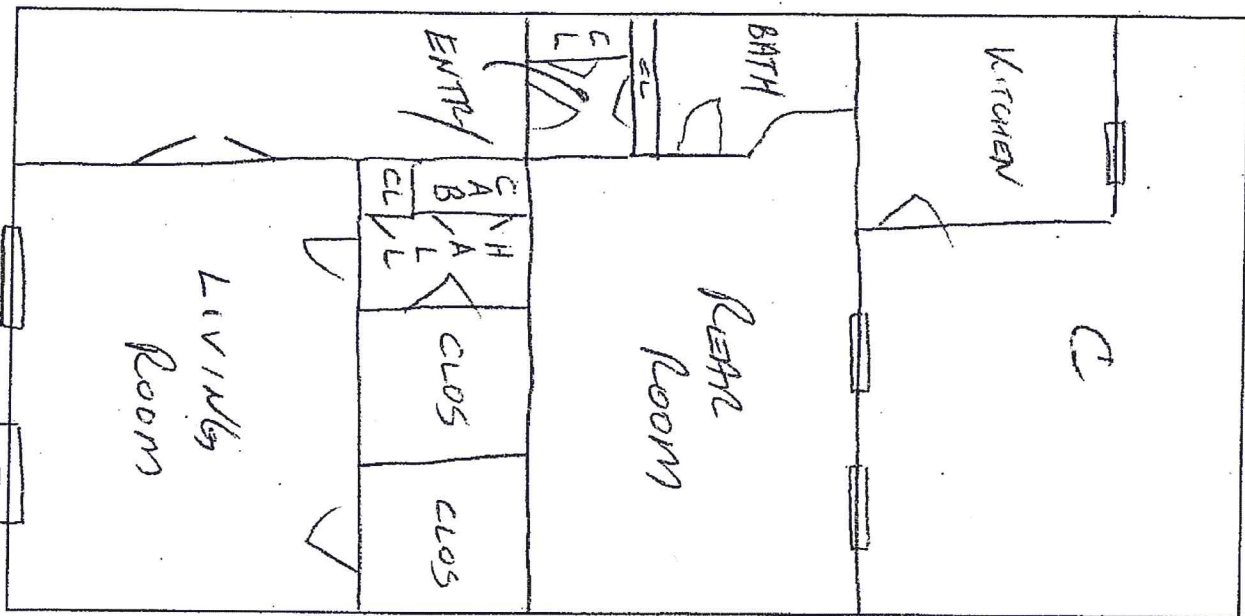
## Floor Plan

A floor plan is included with this report. In each room or area, side A is always the same wall as the front entry, with sides B, C, and D following in a clockwise direction. The sides are noted on the floor plan and in the Data Charts.
